DOCUMENT BOOK  
Structural Inspection

POST OFFICE SQUARE GARAGE  
BOSTON, MASSACHUSETTS

3 March 1984

Comm. 84061 - Structural Inspection of the Post Office Square Garage, Boston, MA

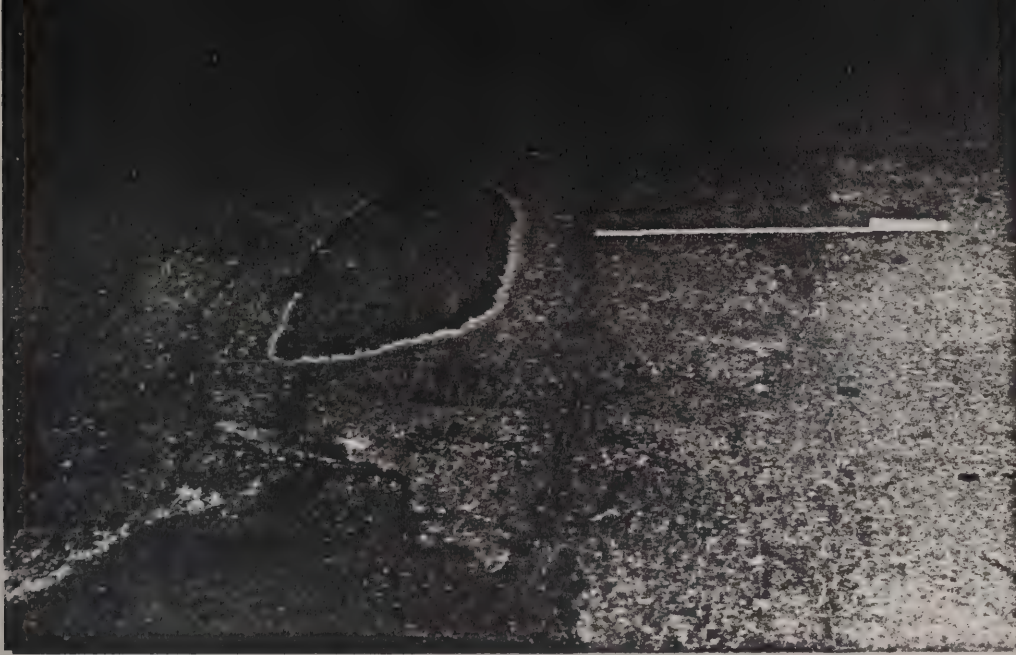
PHOTO 1

intersection area. We noted bituminous patches at 21 of the 44 column areas inspected and at 6 of the column areas not inspected for delaminations. We found numerous bituminous patches at slab areas other than the areas immediately around the columns (Photo 1). We found some delaminated areas of slab along the exterior walls. We also noted some delaminations at column strip-middle strip intersection areas. These areas are areas of slab with a single layer of top steel centered on and running perpendicular to the column line, and located within the middle half of the span.

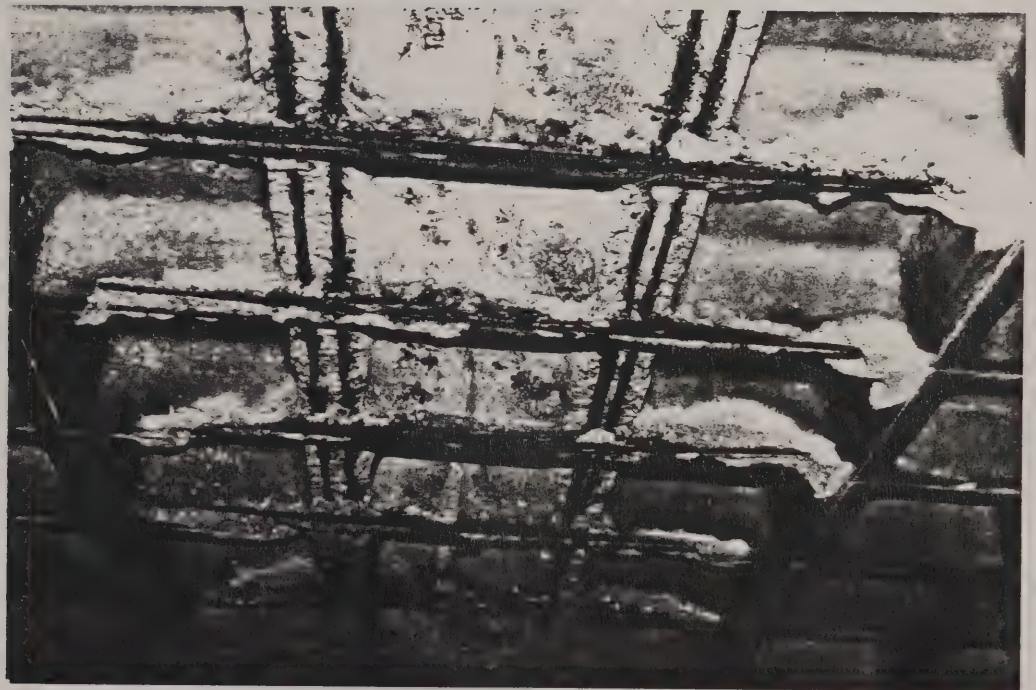
PHOTO 5

3. We performed a condition survey of the underside of the second floor slab. Along the ribs we documented approximately 4,000 lineal feet of either spalled concrete and exposed corroded bottom reinforcing steel, or obvious cracking indicating imminent spalling (Photos 5 and 6). This represents about ten percent of the total length of rib at this level. Approximately ninety percent of this deterioration is

located along the construction joints. The remaining ten percent occurs randomly at locations of inadequate concrete cover over reinforcing bars or conduits in the ribs, or where cracks have formed at conduits in the top slab, thus allowing water to penetrate the slab and contact the ribs. Thirty bays, representing two-thirds of the typical bays, exhibit deterioration. We found some significant deterioration at the wide ribs and beams on the column lines (Photo 7). Typically this deterioration occurs along construction joints.

The spalled concrete and corroded reinforcing at the bottom of the slab is due primarily to direct attack by salt-laden water flowing through the construction joints. Typically at these joints, the ribs on each side of the construction joint as well as a three to four foot width of the ribs perpendicular to the construction joint are severely deteriorated

(Photo 5). Most of the construction joints are in locations where shear and positive moment are less than maximum; however, the deterioration has severely reduced the shear and moment capacities of these members. At bays with construction joints, the capacity of the slab span in the direction perpendicular to the joint is greatly reduced since all of the ribs in this direction are deteriorated at the joint. At the second floor 30 of the 45 typical bays are crossed by construction joints. All of these bays are deteriorated at the joint, most of them severely.

In areas where ribs have suffered severe loss of concrete from their stems, or where the stems are severely cracked or deteriorated and the bottom reinforcing is severely corroded, the entire area of deteriorated slab should be removed and

replaced. We estimate that 15 to 20 percent of the first and second floors would have to be cut out and replaced. In some local areas, cracked and partially spalled concrete protection should be removed, and where reinforcement has not lost excessive amounts of metal, new cover mortar should be applied over an epoxy bonding agent.

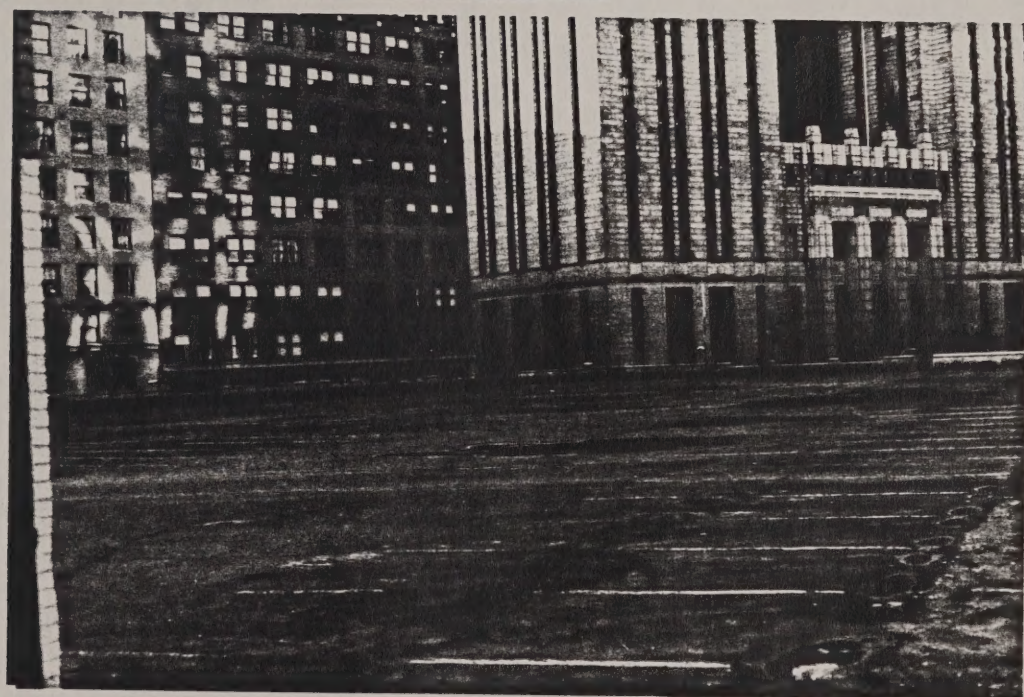
PHOTO 8

7. We conducted a limited visual inspection of the roof level. The bituminous topping is in poor condition. Large patches and many cracks and ruts are evident. We found a few areas of standing water (Photo 8). The parapet is in poor condition with torn or missing base flashing, spalled brick and deteriorated mortar joints (Photo 9). Metal flashing is provided below the limestone copings but is bent and damaged in various locations. Caulked joints between coping stones are badly deteriorated. A section of the parapet around the northeast stair has recently been replaced.

2. The cracked and rutted bituminous concrete pavement at the roof level should be removed and replaced. Removal of this pavement will probably damage the membrane waterproofing layer that has protected the roof slab, so that this membrane will have to be replaced along with the bituminous paving. A liquid applied traffic membrane could be used in lieu of new waterproofing and bituminous concrete to obtain lower first cost, but it would have a shorter life and probably require more maintenance than a pavement protected membrane.

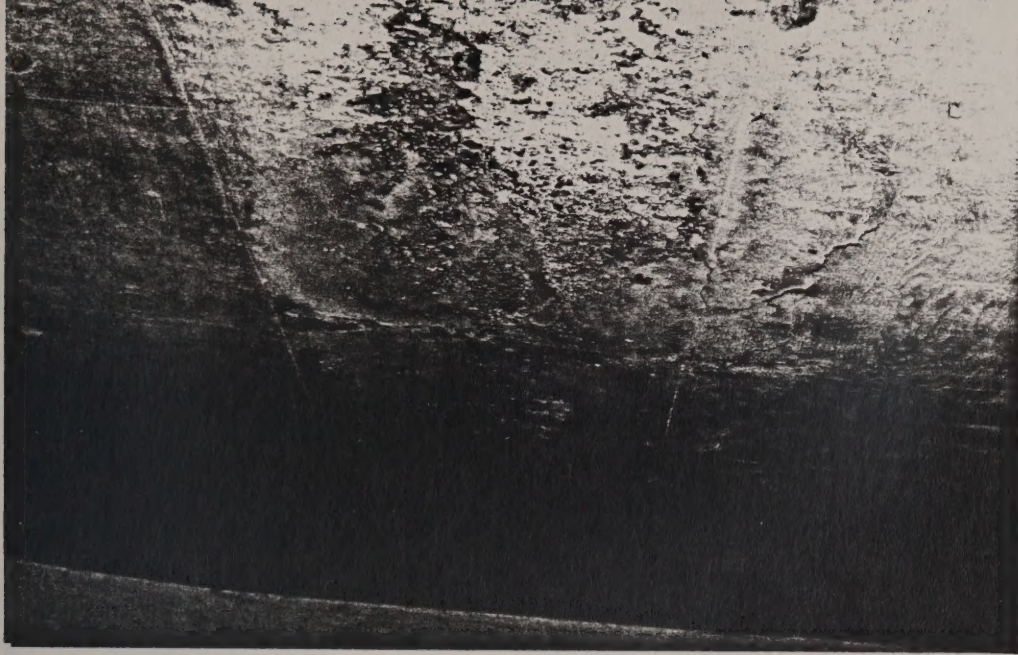
PHOTO 10

8. We visually inspected the exit and entrance ramps. In general the ramps are in good condition; however, there are four small areas on the underside of the ramp slabs that are about to spall (Photo 10). We found a crack in the top of the concrete beam that supports the roof slab and ramp exterior wall on A1 line. This crack is over the northernmost column on A1 line (Photo 11). The concrete corbel that supports the roof slab at A line just west of 6 line on the wall between the up and down ramps is cracked (Photo 12).

The imminent spalling at isolated areas of the ramp slabs occurs in a direction parallel to the slab span and is, as yet, not a cause for concern about the structural adequacy of the ramps. The cracks in the corbel and beam are medium sized and indicate some degree of distress; however, they are not cause for immediate concern about the structural safety of these areas.

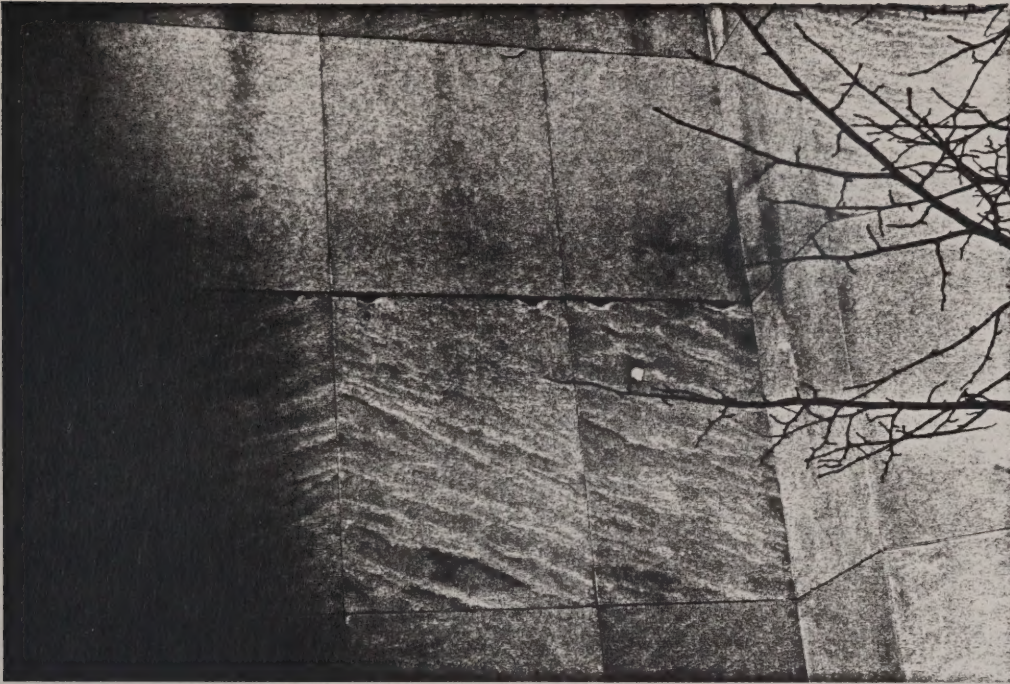
PHOTO 13

9. We walked around the outside of the building to visually inspect the exterior. There are numerous locations where the limestone ashlar ties have corroded and expanded, resulting in spalling at the edges of the panels (Photo 13). We found a few locations where outward movement of the limestone panels has occurred (Photo 14). The northeast corner of the concrete canopy on I line between A1 line and C line is damaged. It appears that it may have been hit by a truck. Many of the metal sills and heads at the windows are buckled.

The spalling of the limestone ashlar panels at anchor locations indicates that the anchors are corroding. This situation is a cause for concern since failure of these anchors will result in the panels falling off the building if loosened by thermal or wind loads. There is presently evidence of some panel movement (Photo 14).

- 1.3 **The Limestone Ashlar Panels.** These panels that form the exterior walls of the garage exhibit local spalling. These spalled areas are probably anchor locations, and the local spalling indicates that the metal anchors are probably corroding. Failure of these anchors would result in panels falling from the building.

4. The exterior of the building requires complete reconstruction to improve aesthetics, remove potentially hazardous limestone panel anchors (that probably are corroded), remove deteriorated metal windows and restore weather protection, if the garage continues as a fully enclosed garage. Alternatively, a reconstructed enclosure could be a screen wall that provides only aesthetic and vehicle impact barrier functions without weather protection.
